Hi Leif/Denrex Aps,

This is to inform you I'm now finished with testing of the Prolan Grease having compared it to other grease types.

The primary function I needed from such a grease was it's ability to treat surface rust found on M12 threaded studs and nuts installed in coastal environments. The tests carried out with Prolan grease were together with special commercially produced protective caps produced by Radoloid (German company) sold here in Denmark by Cobalch A/S (<u>http://www.cobalch.dk/</u>).

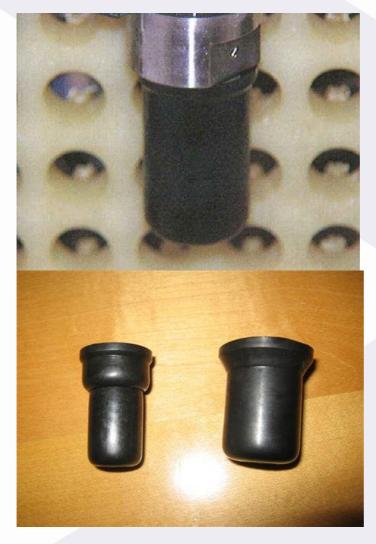
The caps were filled with Prolan grease then fitted to the threaded stud/nut assembly. The assemblies were then subjected to an accelerated salt mist test. The test was conducted at elevated temperatures (70 degrees C) to accelerate the corrosion process.

One weeks testing is approximately the equivalent of some other standard 4 week salt mist tests.

Assemblies with Prolan/Protective Caps and without Prolan/Protective Caps were tested.

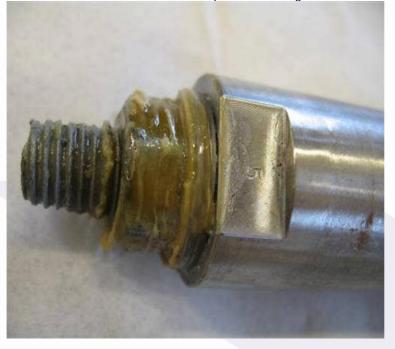
Assemblies with the Prolan/Protective Caps showed no signs of corrosion.....

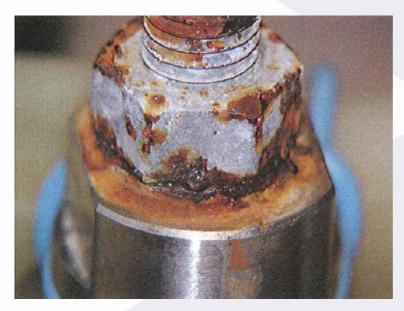
......where as, untreated assemblies had red rust on the thread and nut surfaces.

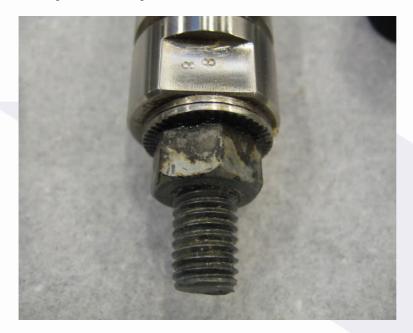
A further test was conducted where Prolan grease was now applied to the previously untreated threaded stud assemblies (red rust present) to evaluate Prolans effectiveness in treating exisiting corrosion. The assembly was subjected to a temperature of approximately 55 degrees C.

Prolan gave the following result shown below.
